# Lookouts, May 2004

# Presentation Objectives:

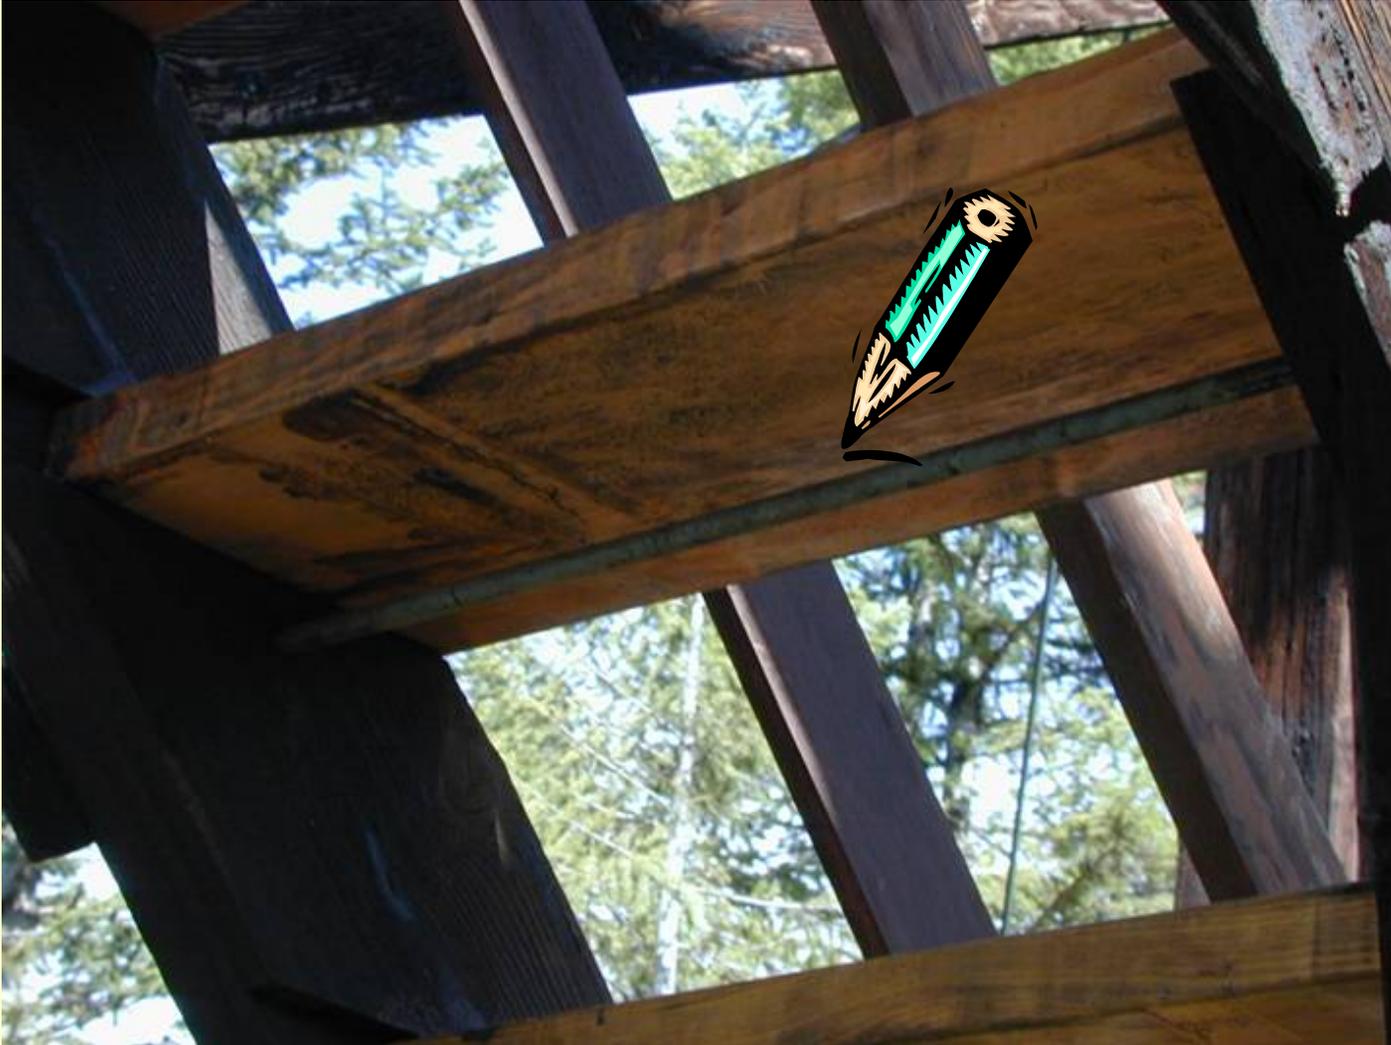
Watch for overly tightened bolts that have pulled through the wood too far.

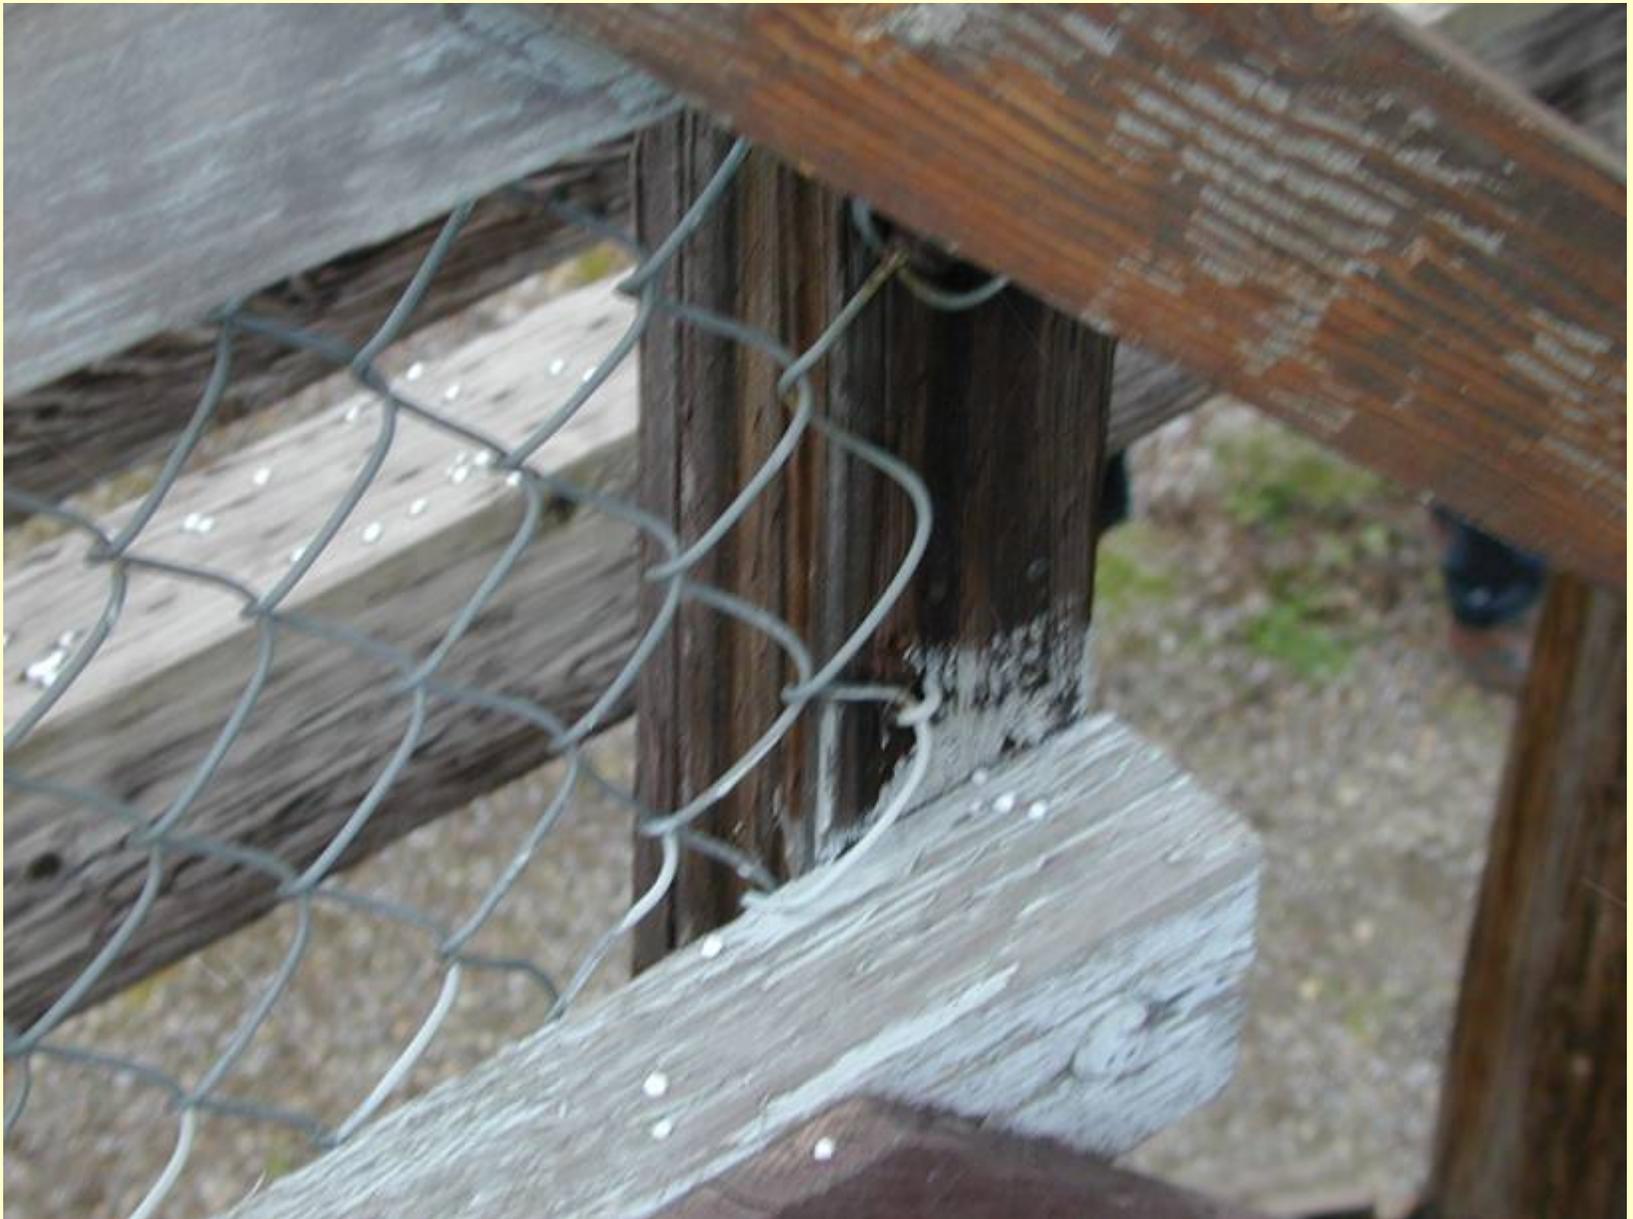
Broken railing is also treated with creosote. Replace with materials that are safe for human touch.

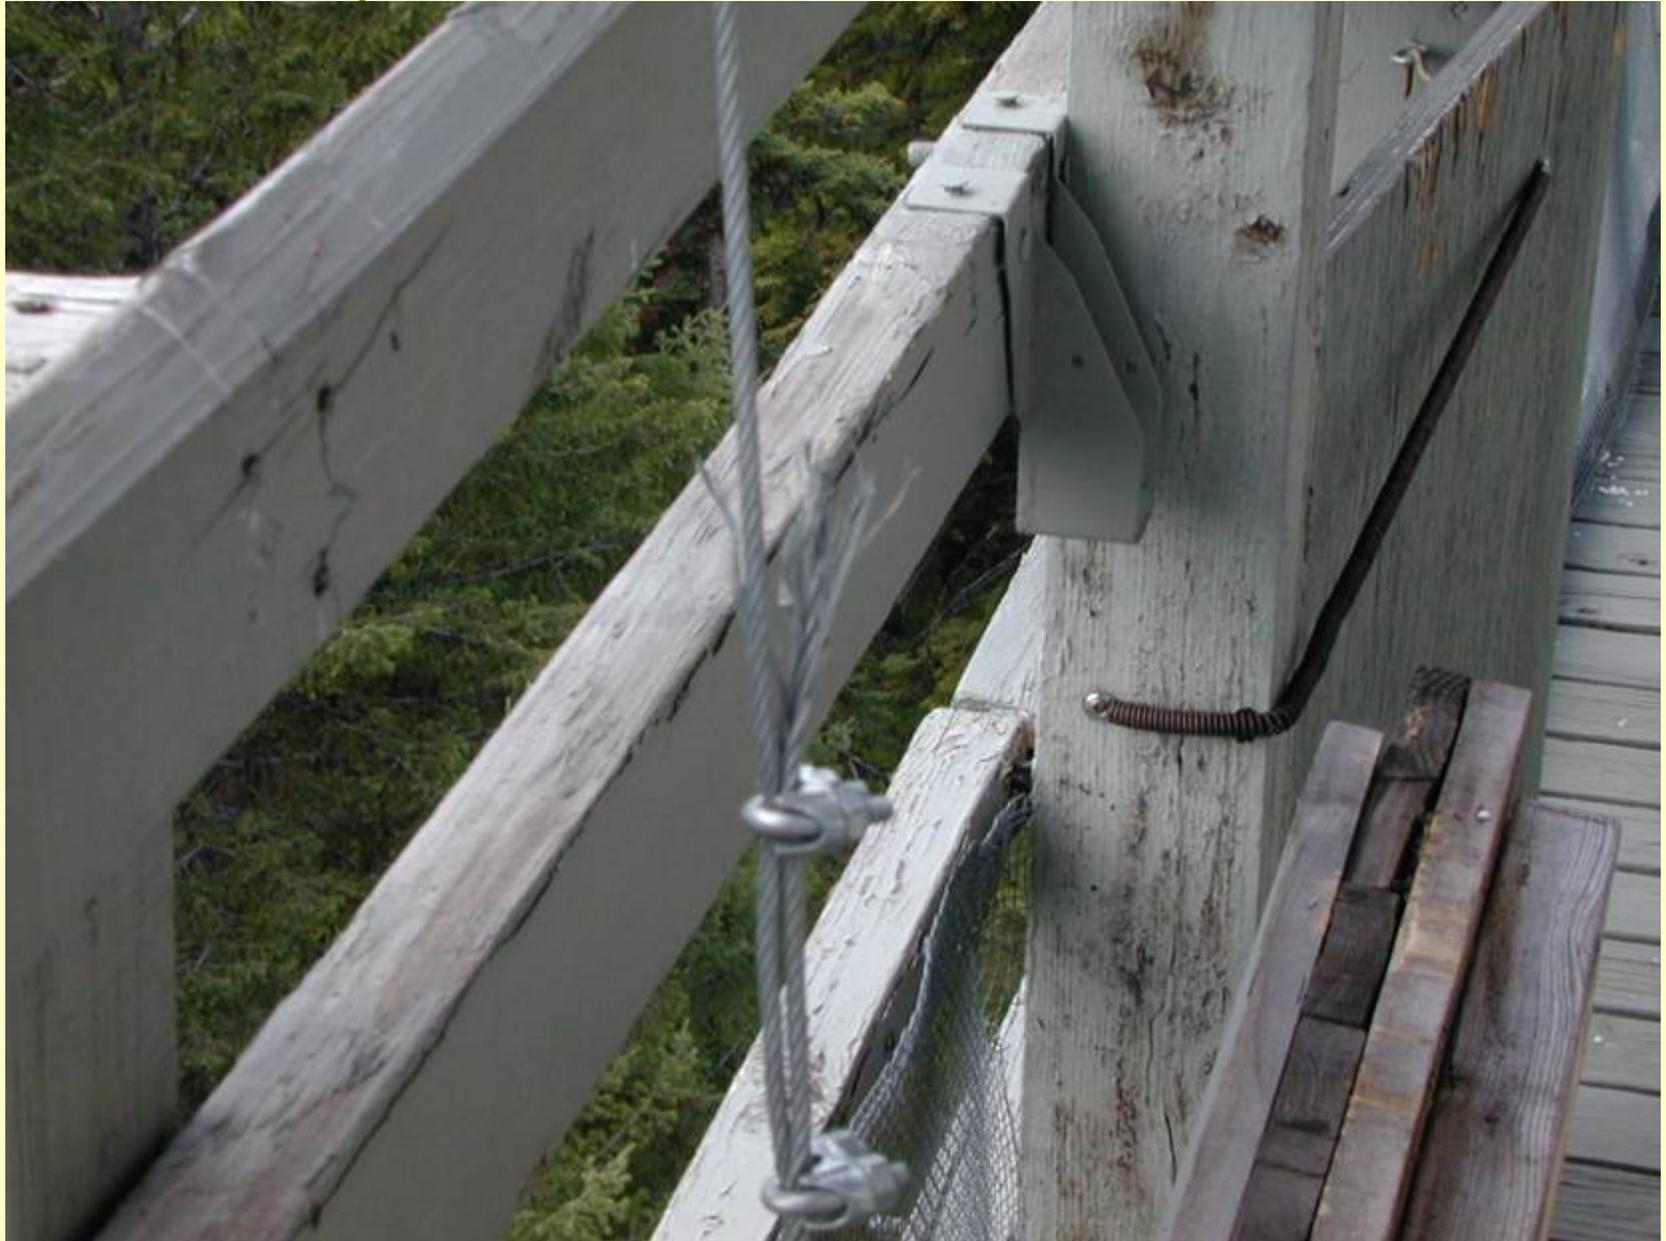
Frayed cable is really about broken under the pulley where you can not see it as well as the obvious fray marked here.
