**Benchmarking The
Pacific Islands
OMIP Conference
Orlando, 2004**

Benchmarking

Study To Establish Benchmark Criteria And
Assign Benchmarks For The U.S. Insular Areas
February 2004

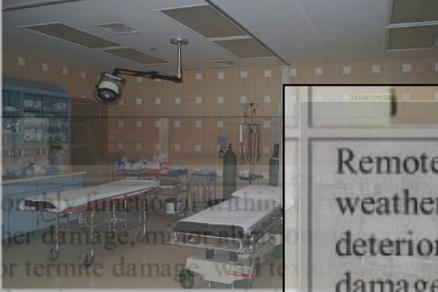
<p>Completely functional within, exterior wall shows no signs of weather damage, painted finishes as originally installed, no rust or termite damage, wall texture and finish intact, ceiling tiles intact, no discoloration or corners missing, adequate lighting, medical gases are properly stored and ready for usage, controlled environment, maintenance program</p>

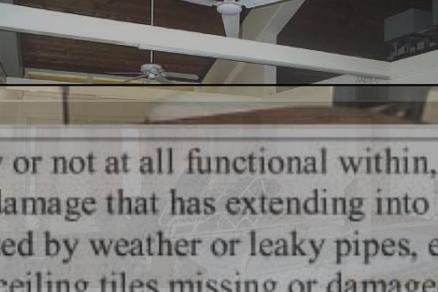
<p>Remotely or not at all functional within, exterior wall shows signs of weather damage that has extending into the building, damaged walls deteriorated by weather or leaky pipes, evidence of rust and/or termite damage, ceiling tiles missing or damaged, inadequate lighting in non surgical areas, ceiling fans no longer functional</p>

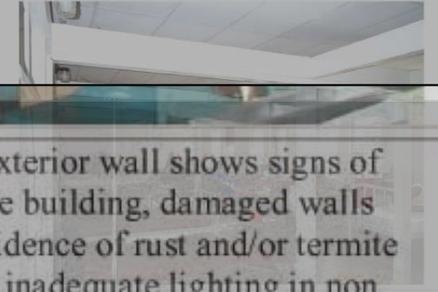
<p>Reasonably functional within, exterior wall shows beginning signs of weather damage, minor abrasions to walls, beginning evidence of rust and/or termite damage, wall texture and finish slightly worn, some discoloration or corners missing on ceiling tiles, lighting primarily provided from outside, medical gases are properly stored and ready for usage, ceiling fans and select areas with controlled environments</p>

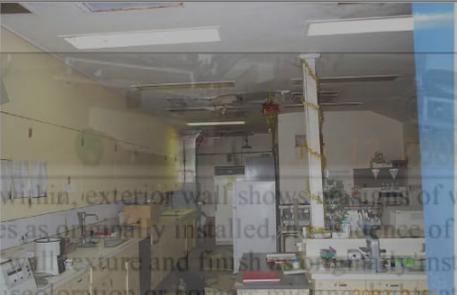
<p>Completely functional within, exterior wall shows no signs of weather damage, painted finishes as originally installed, no rust or termite damage, wall texture and finish intact, ceiling tiles intact, no discoloration or corners missing, adequate lighting, medical gases are properly stored and ready for usage, controlled environment, maintenance program</p>

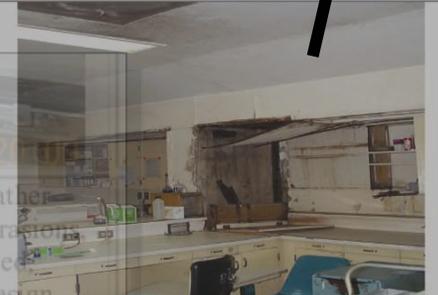
<p>Remotely or not at all functional within, exterior wall shows signs of weather damage that has extending into the building, damaged walls deteriorated by weather or leaky pipes, evidence of rust and/or termite damage, ceiling tiles missing or damaged, inadequate lighting in non surgical areas, ceiling fans no longer functional</p>

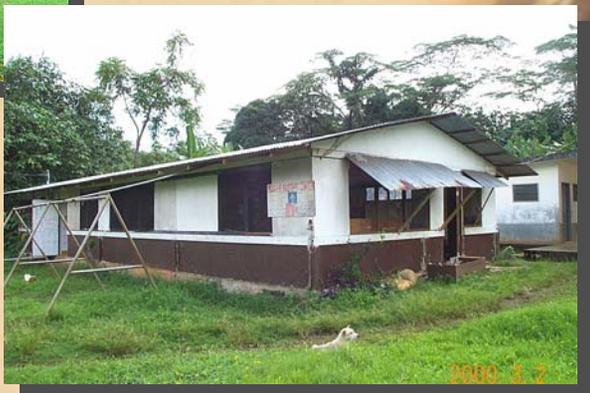
Name	SEKERE
Description	Consist of 6 Building Structures, Grades 1st through 8th
Survey Date	12/2001
Island	Pohnpei
Condition1	3.4
Maintenance1	3.2
Facility	School
Condition2	3.5
Maintenance2	3.3
Type	Elementary
Condition3	3.0
Maintenance3	2.6
Identification	Sekere
Condition4	2.8
Maintenance4	2.0
